# Varnish Removal Unit

Solution for removal of dissolved and suspended soft contaminants from oil in

**Gas & Steam Turbines**

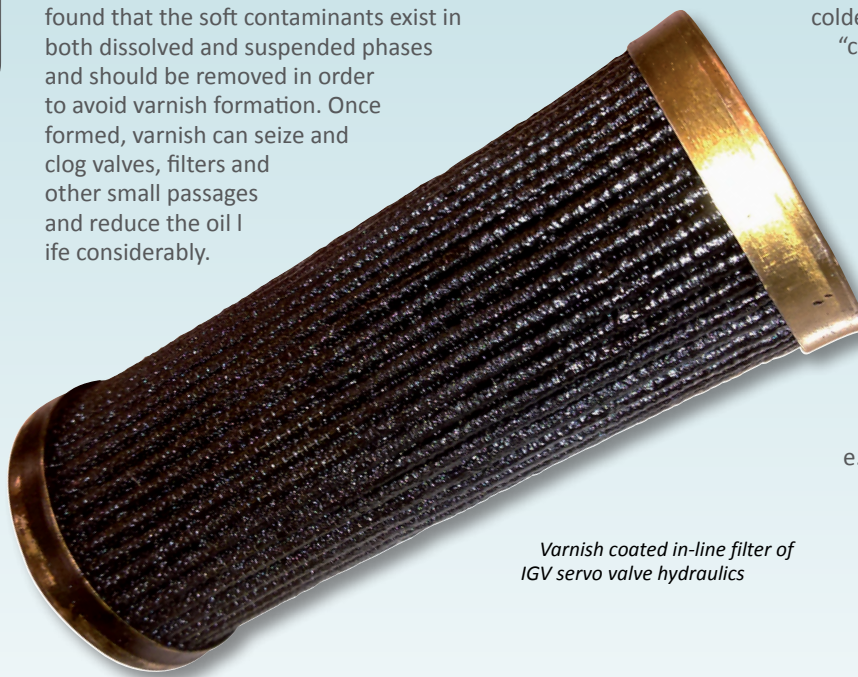
*Varnish coated in-line filter of IGV servo valve hydraulics*

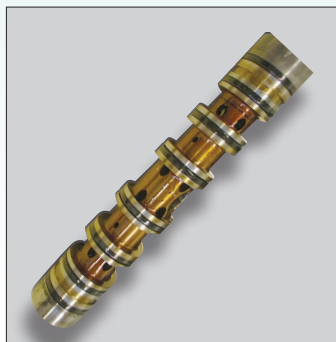
*Varnish on valve spool*
